### The Effect of Operator Performance on the Condition of Sewage Sludge Treatment Plants

Since 2019, Jayapura City has had a Wastewater Management Operator, but the city's Safe Sanitation target has not been achieved. This study aims to analyze the effect of operator performance on the condition and operational effectiveness of the Septage Treatment Plant (STP). Using a quantitative approach, this study explores the relationship between the Service Aspect, Financial Aspect, Operational Aspect, & Human Resource Aspect of the Wastewater Operator, to the physical condition and performance of the STP. The results showed that the performance of the Jayapura City UPTD PALD operator is still less than the performance standard, this can be seen from the Performance Index worth 4.542 points (category D). The operator performance factor that has the most significant influence on the condition of the Koya Koso STP is the Operational Aspect. This aspect only contributes 0.688 points out of a potential maximum score of 2 points. This is in line with field conditions, where a series of treatment units are no longer functioning normally. This study provides recommendations for light rehabilitat

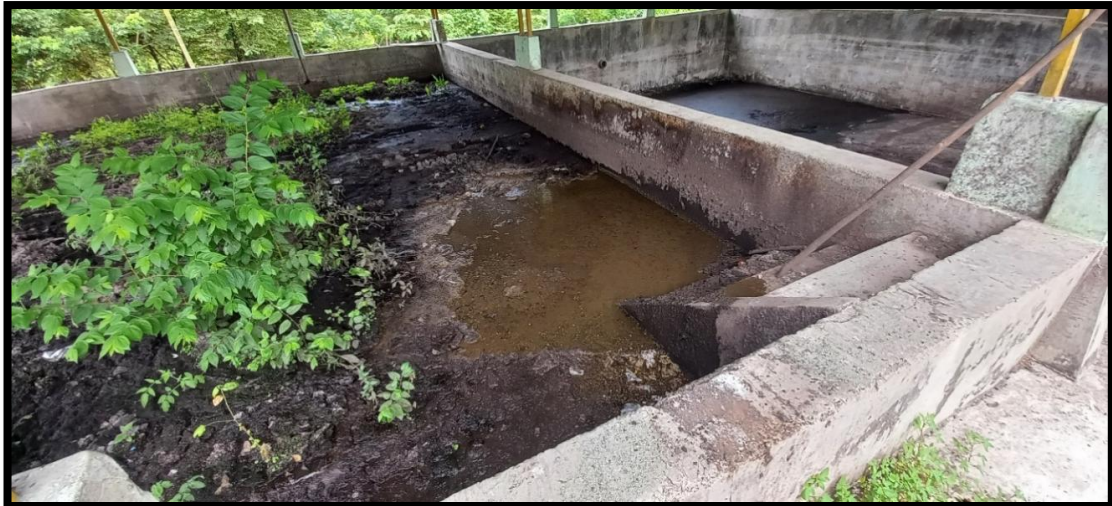
### **Solid Separation Chamber (SSC)**

From the physical condition observations, out of 8 evaluation criteria for the SSC tank, only 2 criteria met the standards: the presence of a screen/bar screen and the slope of the tank floor. When calculated as a percentage, the physical condition score is 25%.

Meanwhile, the results of the functional condition observation indicate that the SSC tank is no longer functioning normally. There is no filter medium to separate solids and liquids, so solid particles enter the anaerobic pond. The connecting pipe to the anaerobic pond is also leaking and detached, causing liquid to overflow into the backyard of the SSC tank. It can be concluded that this building falls into the category of "Very Poor Functioning."

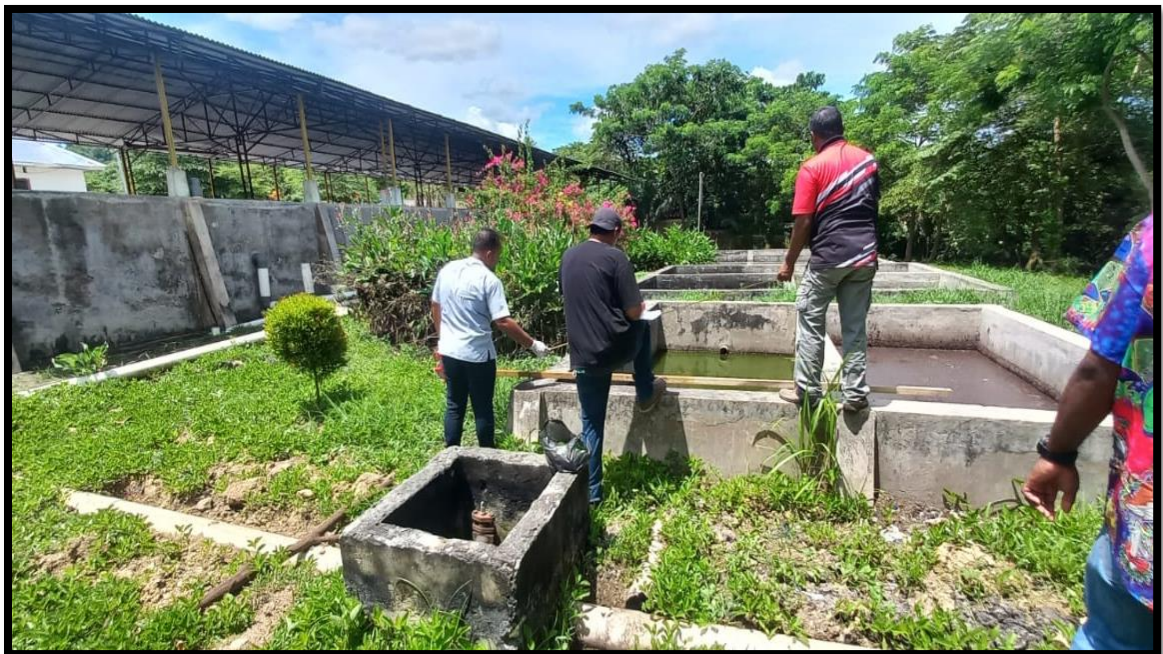
### Anaerobic Pond

Based on the physical condition observation results, out of 4 assessment indicators, the Anaerobic Pond meets the standards for 2 criteria, namely pond depth and length-to-width ratio. When expressed as a percentage, the physical condition value is 50%. Meanwhile, the results of the functional condition observation indicate that the anaerobic pond is still functioning normally on the right side. The left side of the pond is no longer connected to the SSC tank. Additionally, evidence was found that sewage sludge is often disposed of directly without passing through the SSC tank. This activity is carried out outside of the operator's working hours. It is concluded that this structure falls into the “poorly functional” category.

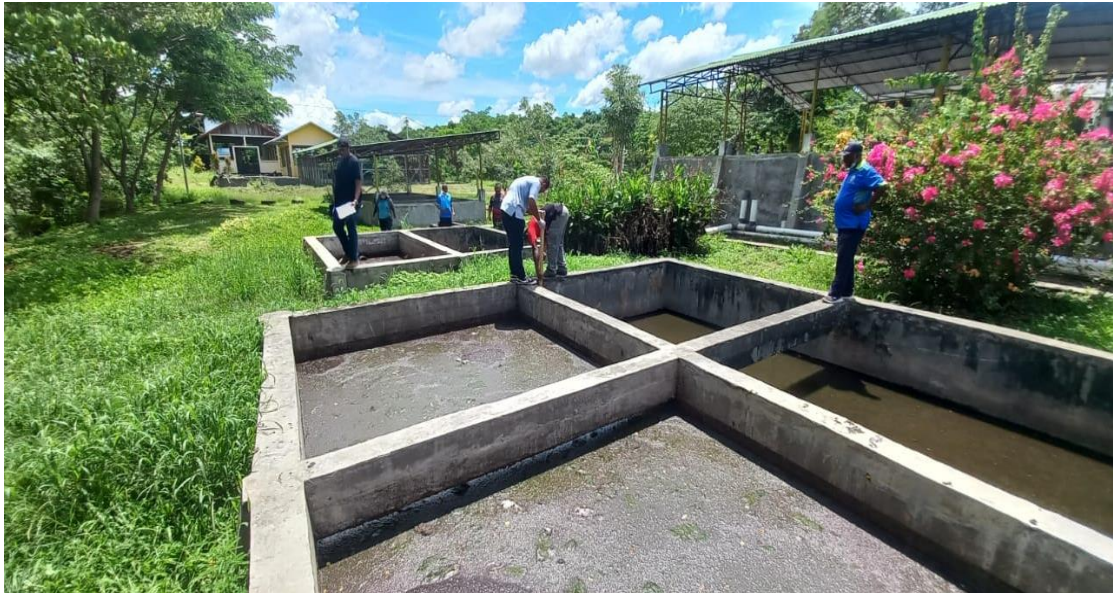
### Facultative Pond

The observation results indicate that the design parameters meet the design criteria. The existing condition of this pond consists of two pond units arranged in series, rectangular in shape with concrete construction. Based on field observations, there is a significant amount of brown algae on the upper surface of the facultative pond. The interconnection pipes to the maturation pond are in good condition. However, Pond 1

(on the left) is not functioning due to the absence of flow from the anaerobic pond. Out of 4 assessment indicators, the facultative pond meets 1 indicator. When calculated as a percentage, the physical condition value is 25%. Meanwhile, the observation results on functionality indicate that the facultative pond is still functioning normally, specifically the right-hand pond. The left side of the pond is no longer connected to the anaerobic pond. It is concluded that this structure falls into the category of poorly functioning.

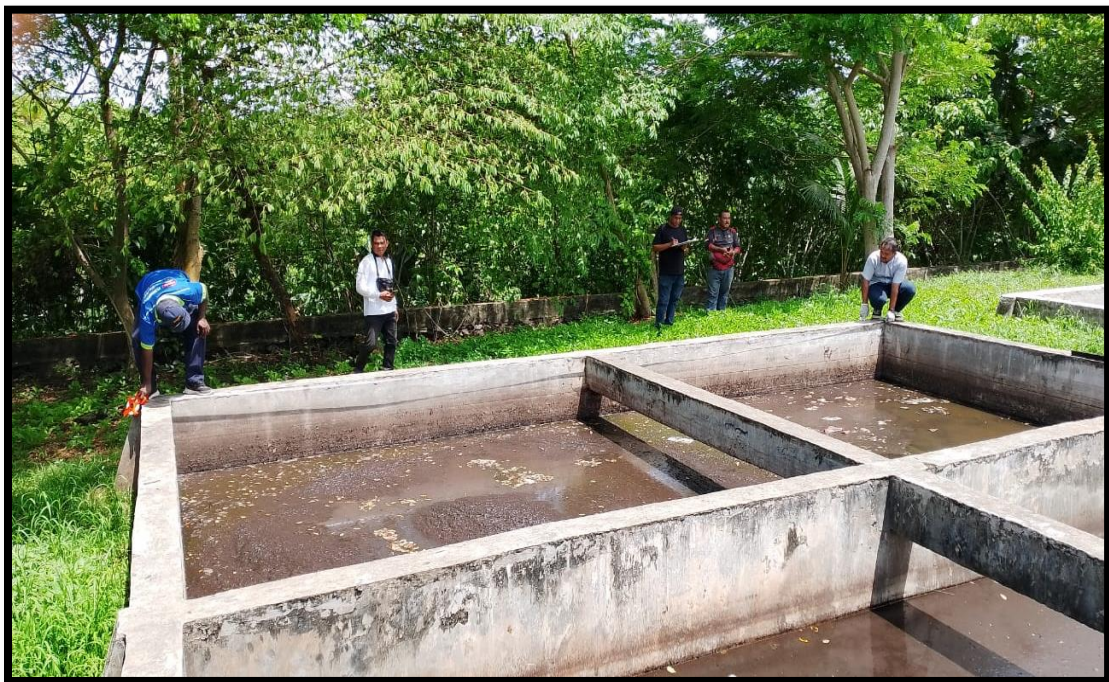
### **Maturation Pond**

The field visit results indicate that the design depth parameter of the maturation pond meets the design criteria. Out of 3 evaluation parameters, this structure meets all criteria, with a percentage of 100%. Regarding functionality, the existing condition of the maturation pond, which consists of two units made of concrete, shows no structural damage. However, only pond number 2 (on the right) is operational, filled with thick sludge. It is concluded that this structure falls into the category of underperforming.

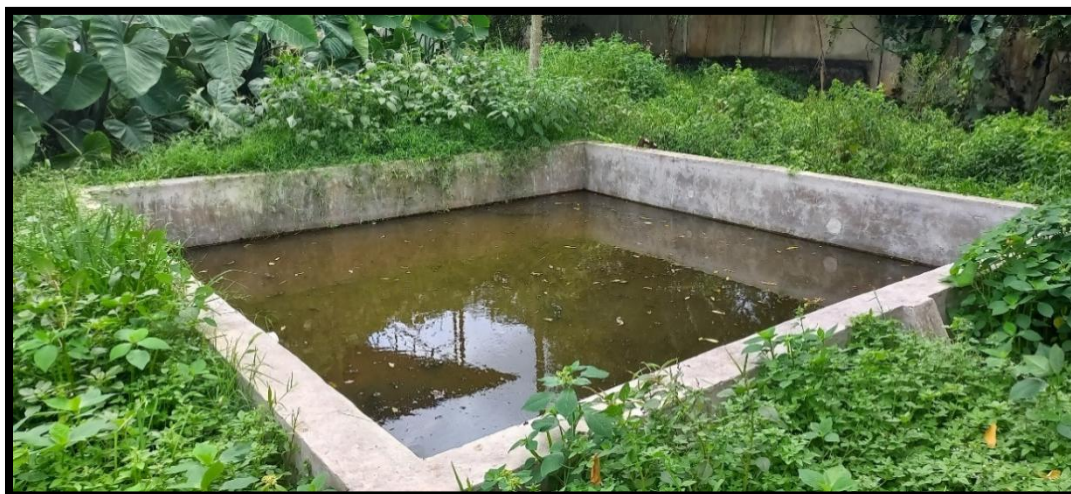
### Constructed Wetland

The current condition of the constructed wetland shows no structural damage visually, but there is thick sludge in the pond. It is suspected that sewage trucks are directly discharging into the wetland pond without passing through the SSC and stabilization pond. The ratio of the pond's length to width does not meet the design criteria. Out of the 5 evaluation criteria, the structure meets 2 design criteria, accounting for 20%. Regarding functionality, on-site observations reveal a flow from Pipe 1 (left side) toward the constructed wetland, while Maturation Pond 1 (left side) is not functioning. There is a strong suspicion of a leak, causing overflowing liquid from SSC Pond 1 to directly enter the constructed wetland pond. This is dangerous for the environment, as the liquid has not undergone treatment. It is concluded that this structure falls into the category of poorly functioning. Based on design criteria, the sludge drying pond does not yet meet the requirements. Additionally, due to its distance of approximately 30 meters from the SSC pond, this has been a concern for operators in transferring solids, as it is considered too far.

Furthermore, there is no drainage pipe for filtered water (filtrate) in the sludge drying tank. This needs to be installed to channel the remaining liquid for treatment in the stabilization pond. Out of 5 evaluation criteria, only 1 criterion is met, which amounts to 20% when calculated as a percentage.

This structure can still be used, but

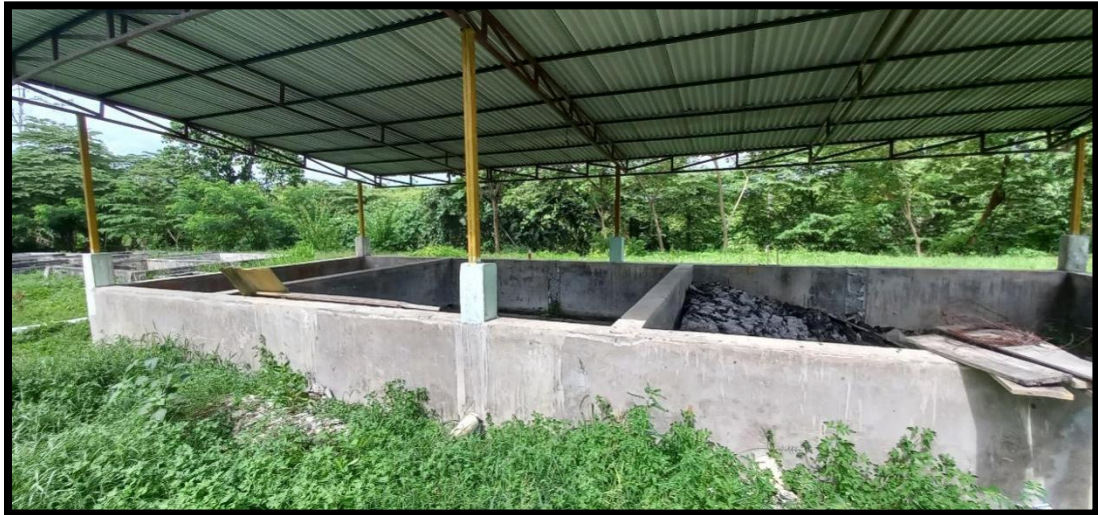
### Sludge Drying Bed (SDB)

Based on design criteria, the sludge drying pond does not yet meet the requirements. Additionally, due to its distance of approximately 30 meters from the SSC pond, this has been a concern for operators in transferring solids, as it is considered too far. Furthermore, there is no drainage pipe for filtered water (filtrate) in the sludge drying tank. This needs to be installed to channel the remaining liquid for treatment in the stabilization pond. Out of 5 evaluation criteria, only 1 criterion is met, which amounts to 20% when calculated as a percentage. This structure can still be used, but it requires the addition of filter media and the installation of a filtrate discharge pipe. In terms of functionality, this structure falls into the category of being less functional.
