## Application of the Walkability Concept to the Yos Sodarso Road Corridor - Mardika Beach Road, Ambon City

Willem Dominggus Nanlohy<sup>1</sup>✉, Risal Rasyid<sup>2</sup>

<sup>1,2</sup>Regional and City Planning Study Program, Universitas Pattimura, Ambon, Indonesia

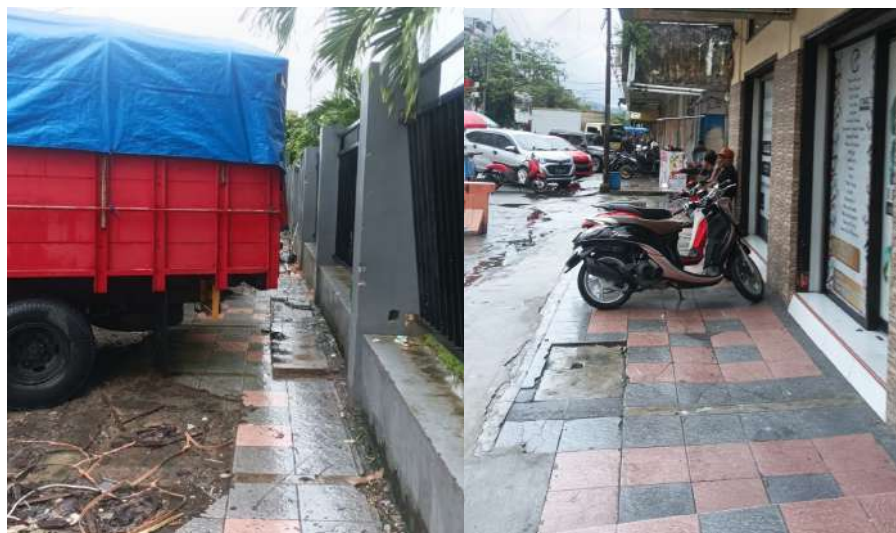
## Figure 2. Misuse of the function of the sidewalk as a parking space

of the road corridor served by pedestrian paths with The average width of pedestrian paths is  $\pm 2$  meters . Some of the problems found in segment I were pedestrian paths that were damaged because they were used as parking locations for loading and unloading trucks and as parking areas for two-wheeled vehicles.

a) Loading and Unloading Truck Parking b) Two-Wheeled Vehicle Parking

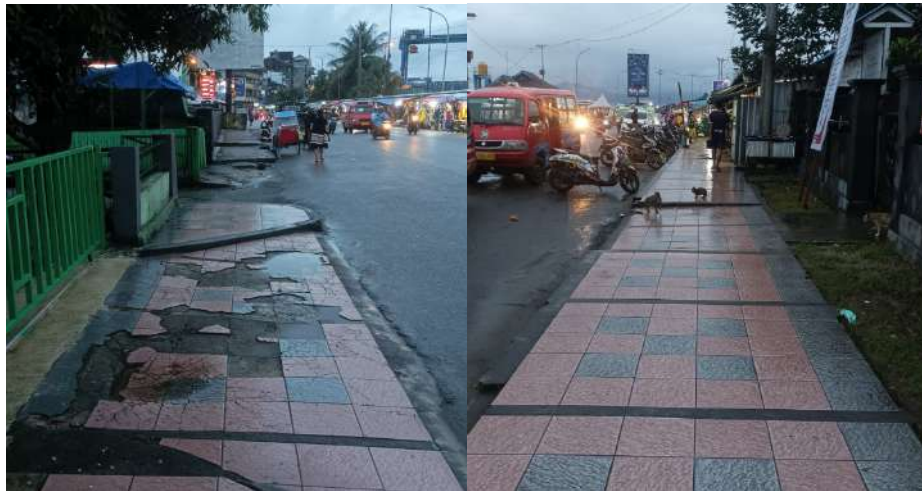
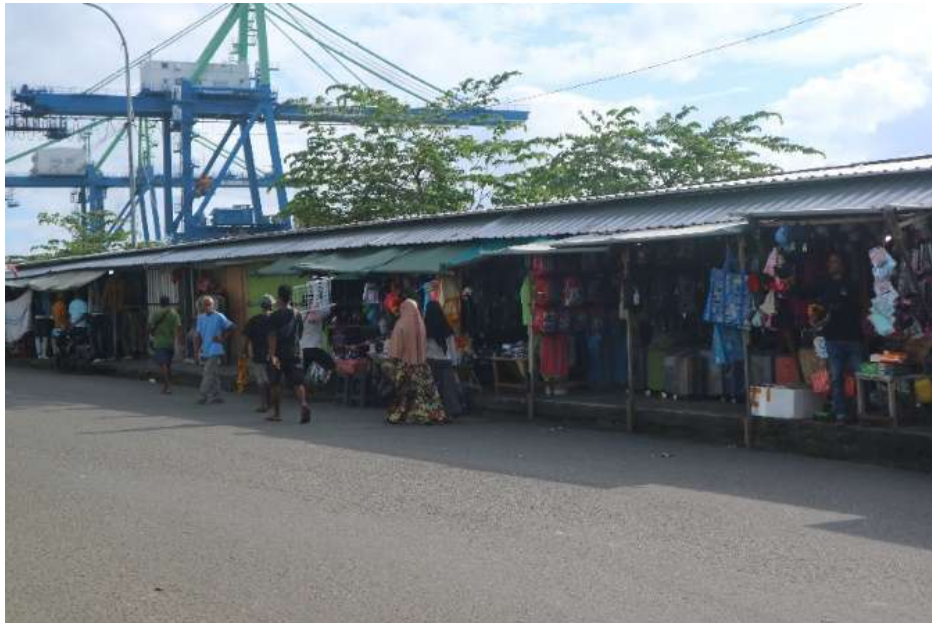
## Figure 3. Condition of pedestrian paths in segment II

segment for  $\pm 321$  meters or 80.25% of the road corridor served by pedestrian paths with an average of - The average width of the pedestrian path is  $\pm 2$  meters. However, the pedestrian path is covered by traders' stalls for 400 meters.

a) Pedestrian Paths in Damaged Condition b) Pedestrian Paths in Good Condition

c) Pedestrian Paths Used as Traders' Stalls

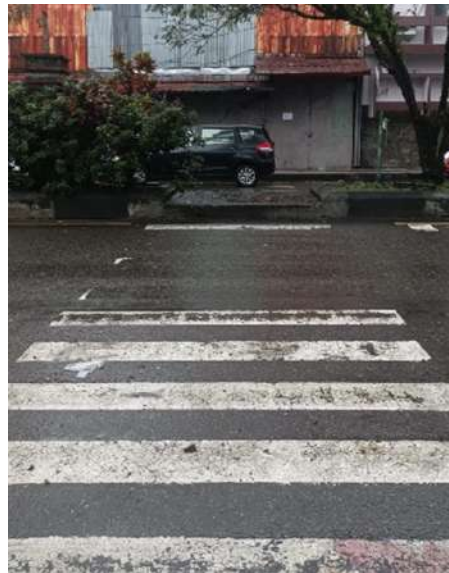
**Figure 4. Condition of Crossing Lane in Segment I**

front of the Ambon Plaza shopping center. The condition of the crossing lane is quite good, this can be seen from the crossing lines which are still there, but some of the lines have faded.

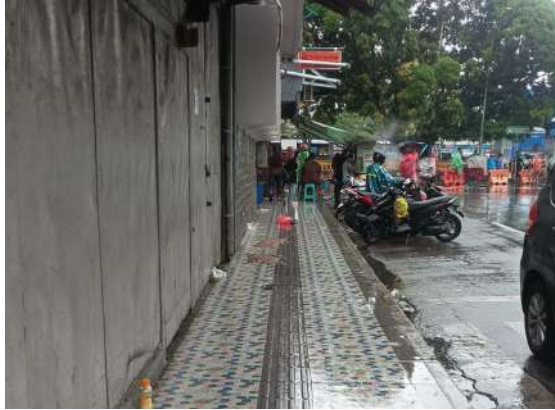
**Figure 5. Condition of the Disabled Route in Segment I**

In segment I there is a disabled path along the south side pedestrian path. The condition of the disabled path is quite good, but it is cut off at several points, making it difficult for pedestrians with special needs.

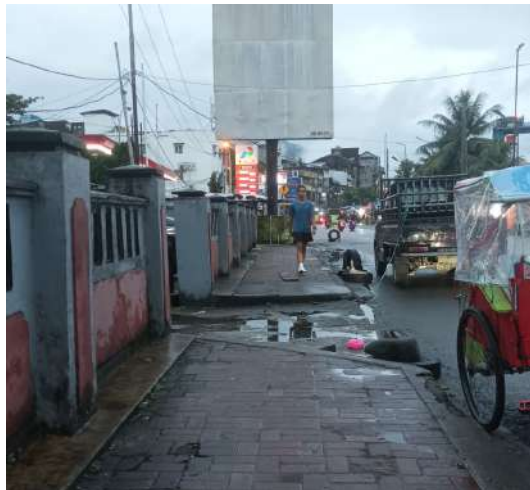
**Figure 6. Pedestrian path conditions with minimal facilities in Segment II**

In segment II in this corridor there are no facilities on the pedestrian

path which causes discomfort for pedestrians.

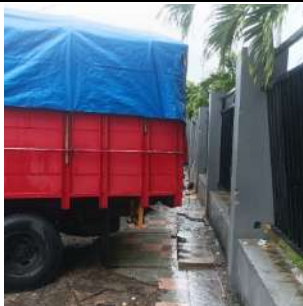
2
Availability of Pedestrian Paths	<ul style="list-style-type: none"> <li>Need</li> <li>Availability</li> <li>Condition of pedestrian paths</li> </ul>	Pedestrian paths are available, but the majority are used as vehicle parking and loading and unloading activities, thus causing inconvenience for pedestrians.

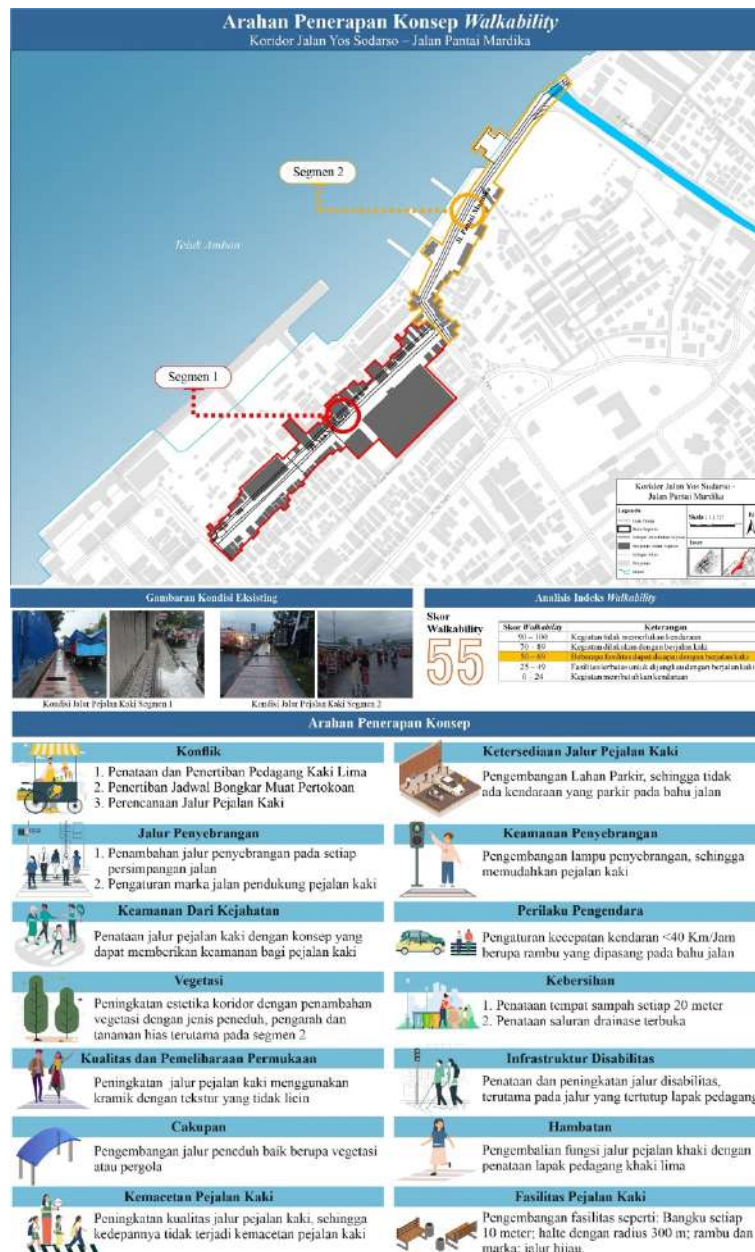
Figure 9. Directions for Implementing the Walkability Concept for the Jalan Yos Sudarso Corridor - Jalan Pantai Mardika, Ambon City

Application of the walkability concept which will refer to the index value and value or problem of each variable. The direction of

this walkability corridor concept can be seen in Figure 9:

- 1) Arranging and controlling street vendors who carry out activities on pedestrian paths,
- 2) Controlling schedules for loading and unloading activities which are carried out during off-peak hours so that they do not disturb pedestrian comfort.
- 3) Planning pedestrian routes, especially on sections of routes that do not yet exist.
- 4) Addition of crossing lanes at every road intersection as well as pedestrian support facilities.
- 5)

Arrangement of pedestrian paths with a concept that can provide safety and comfort for pedestrians .
